ANNUAL REPORT FOR 2011

**Phipps Creek Site #11 Mitigation Site
Yancey County
TIP No. R-2518B**

Prepared By:
Natural Environment Unit & Roadside Environmental Unit
North Carolina Department of Transportation
December 2011

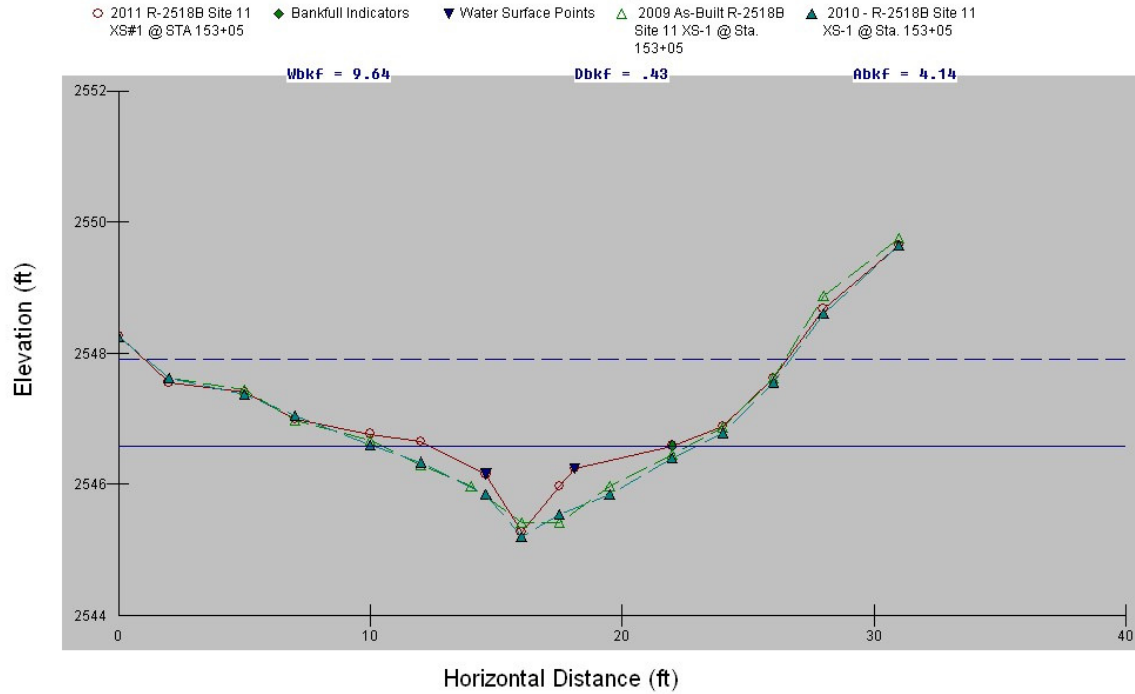
R-2518B Site 11 XS#1 @ STA 153+05

Based on comparisons of the As-Built to the monitoring data, all of the cross sections appear stable with little or no active bank erosion. Graphs of the cross sections are presented in Appendix A. Future survey data will vary depending on actual location of rod placement and alignment; however, this information should remain similar in appearance. The longitudinal profile showed that the channel was stable for the 2011 monitoring evaluation. Pebble counts were not required per the permit conditions and therefore were not completed.

Site #11: Cross-Section #1 (Riffle) Abbreviated Morphological Summary					
	2010	2011	2012	2013	2014
Bankfull Cross Sectional Area (ft. ²)	5.66	4.14			
Maximum Bankfull Depth (ft.)	1.19	1.32			
Width of the Floodprone Area (ft.)	23.7	25.52			
Bankfull Mean Depth (ft.)	0.54	0.43			
Width/Depth Ratio	19.37	22.42			
Entrenchment Ratio	2.27	2.65			
Bankfull Width (ft.)	10.46	9.64

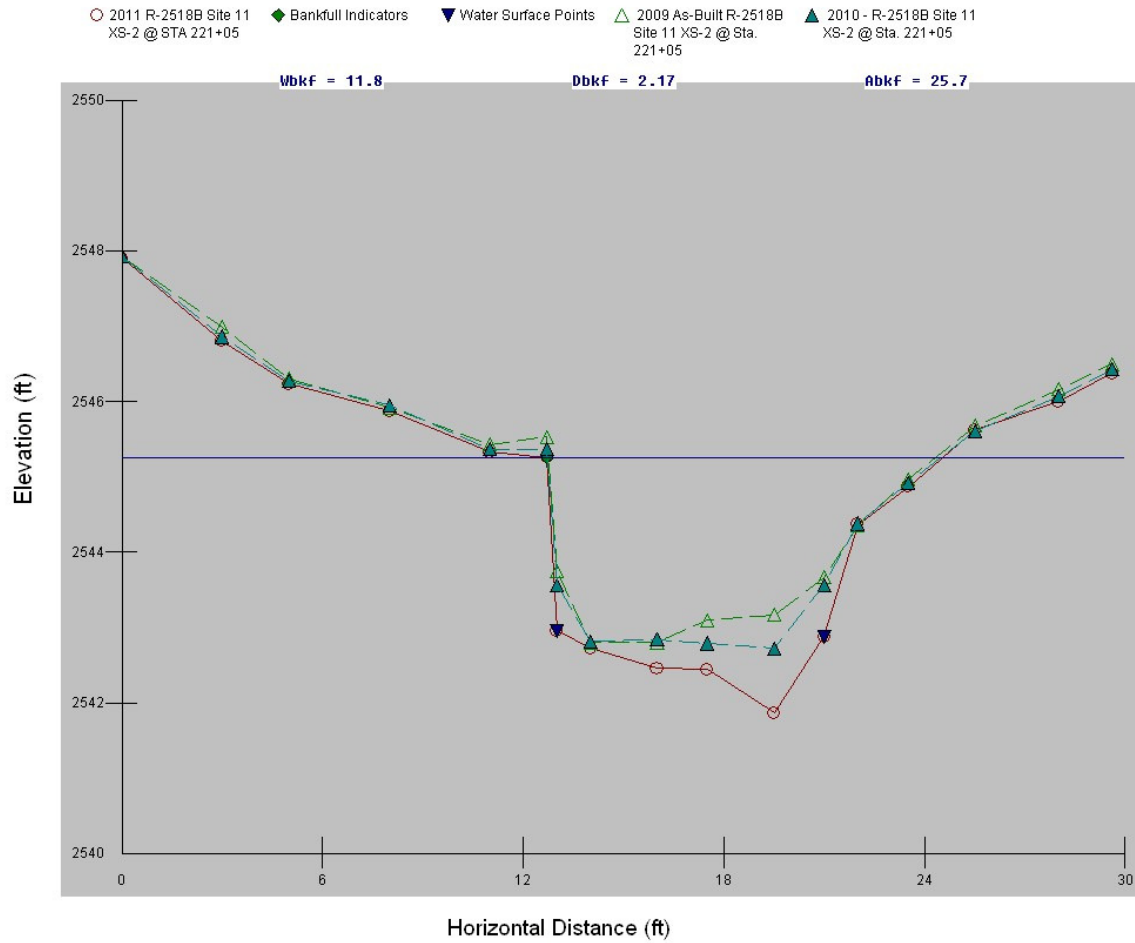
R-2518B Site 11 XS-2 @ STA 221+05

Site #11: Cross-Section #2 (Pool) Abbreviated Morphological Summary*					
	2010	2011	2012	2013	2014
Bankfull Cross Sectional Area (ft. ²)	22.69	26.91			
Maximum Bankfull Depth (ft.)	2.65	3.39			
Bankfull Mean Depth (ft.)	1.87	2.27			
Bankfull Width (ft.)	12.1	11.84
